Once the site of an abandoned sewage plant, Jambalaya Park in Gonzalez, La., stands as testimony to just how ambitious a renovation project can be – and of how tangled the path to success sometimes becomes. As watershaper and watergarden specialist Les Ewen reports, the first attempt at installing the park’s fountain and Koi pond ended in a shambles, at which point he and his staff stepped in to put the city’s plans for the park back on track.

BY LES EWEN

JAMBALAYA

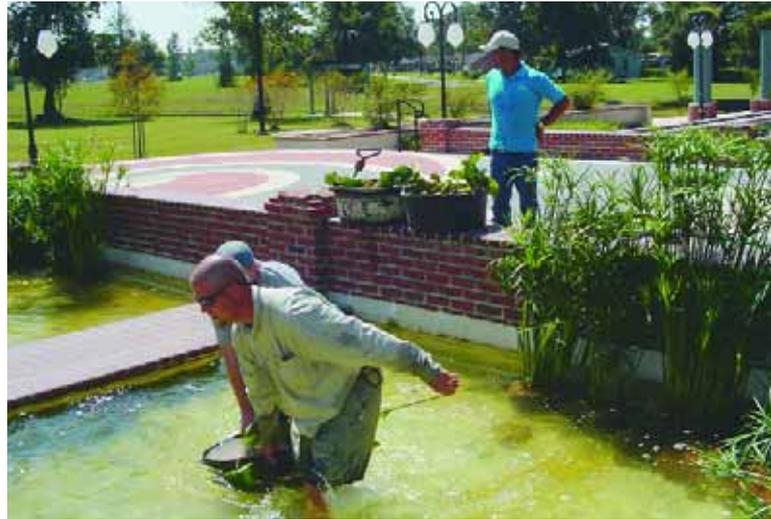
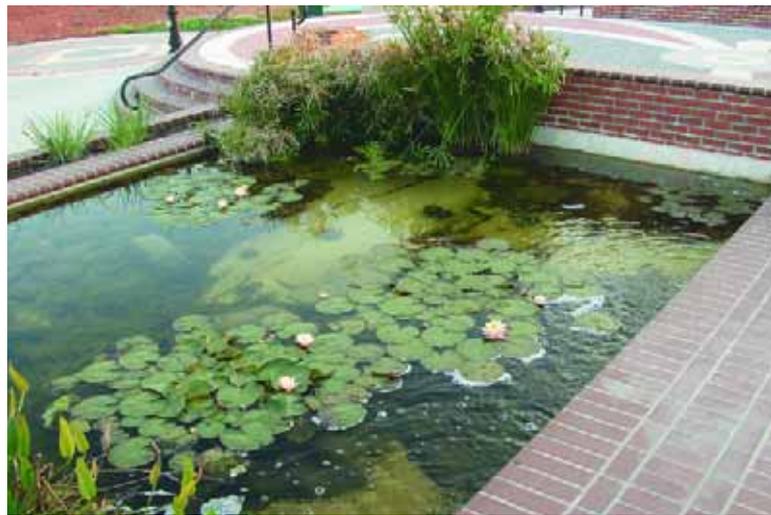
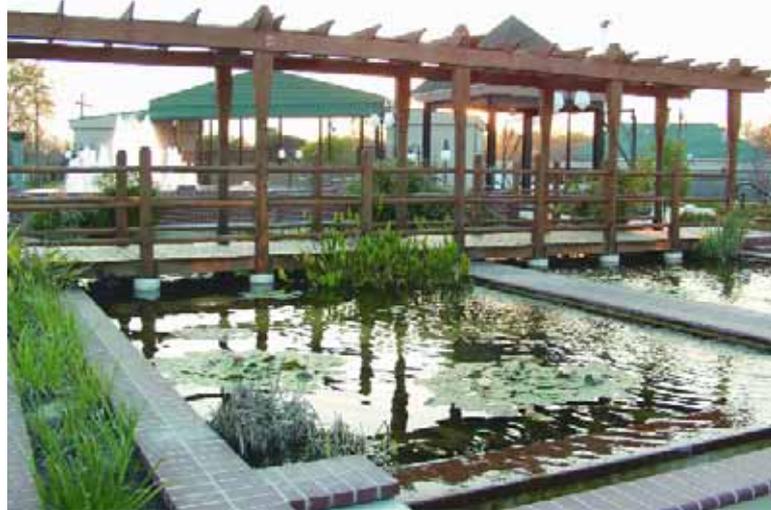
We softened the hard edges of the pond by introducing plants of various heights at spots along the perimeter. We also used lilies and arrangements of stones to add visual interest to the open sections of water and increase the drama – especially in views from the wooden bridge.

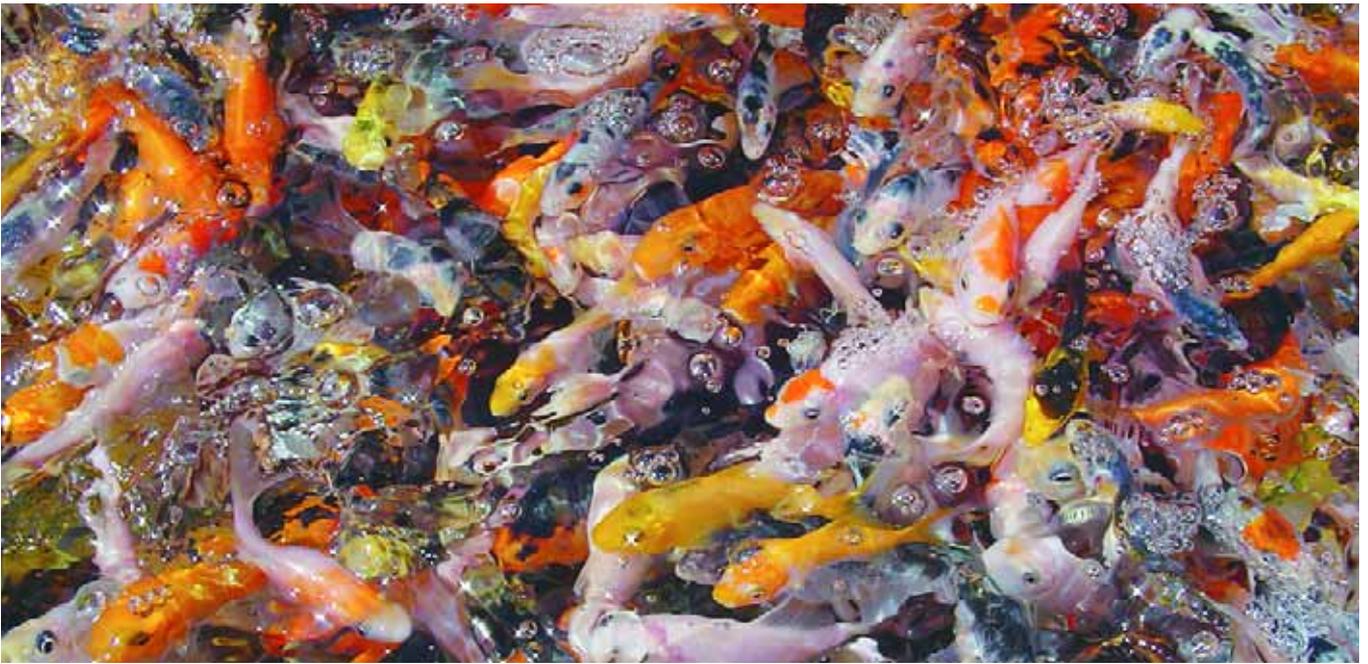
We reintroduced a large number of Koi to get the pond up and running again. They seemed to appreciate the rock formations we'd added – perhaps seeing them as camouflage in hiding from birds and other creatures who targeted the fish as 'snack food.'

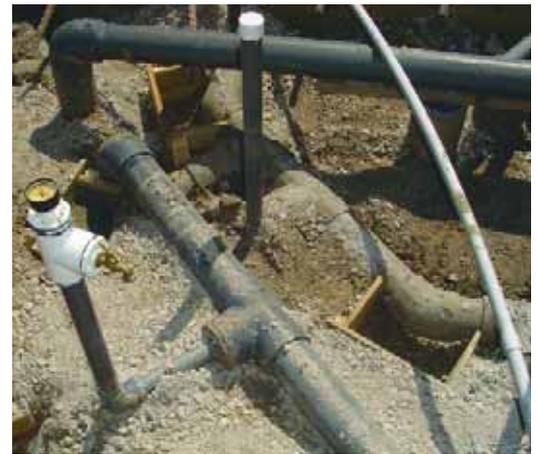
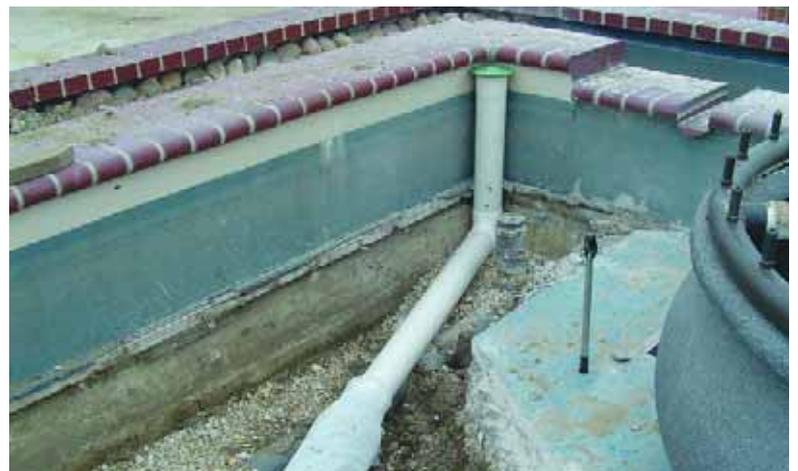
Reinstalling the fountain was straightforward, but given the history we were certain to pressure-test the lines on a continuous basis. A key system addition: pressure-release lines set in the corners to keep the concrete from buckling and alert staff to the recurrence of the kinds of problems that destroyed the original installation.

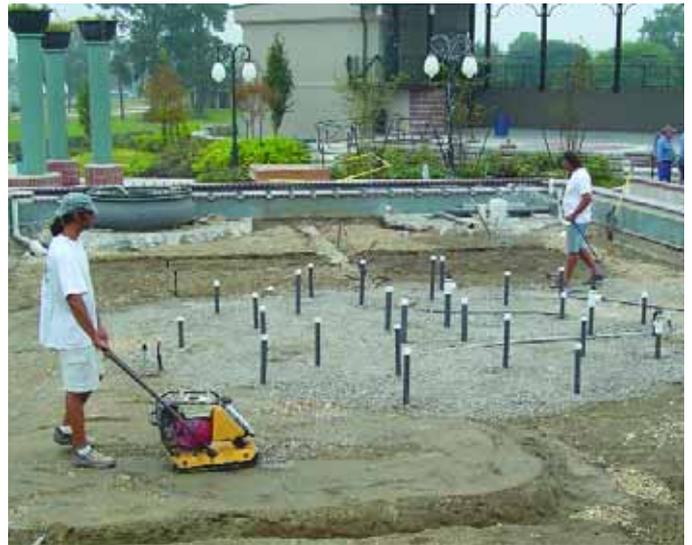
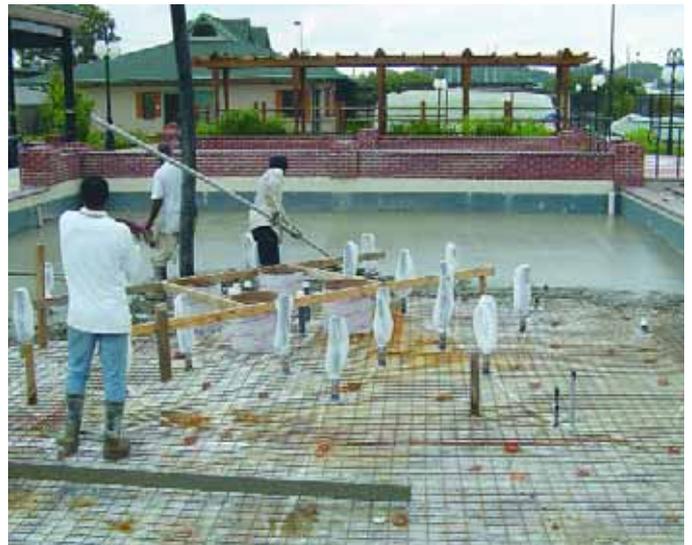
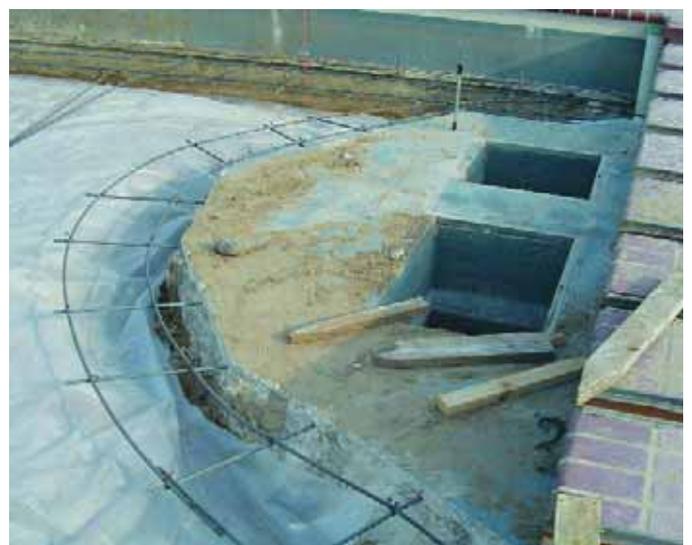
We were determined not to revisit the inadequacies of the original fountain basin, so we compacted the substrate, added rebar and steel mesh and tied what little was left of the original structure into the new work.

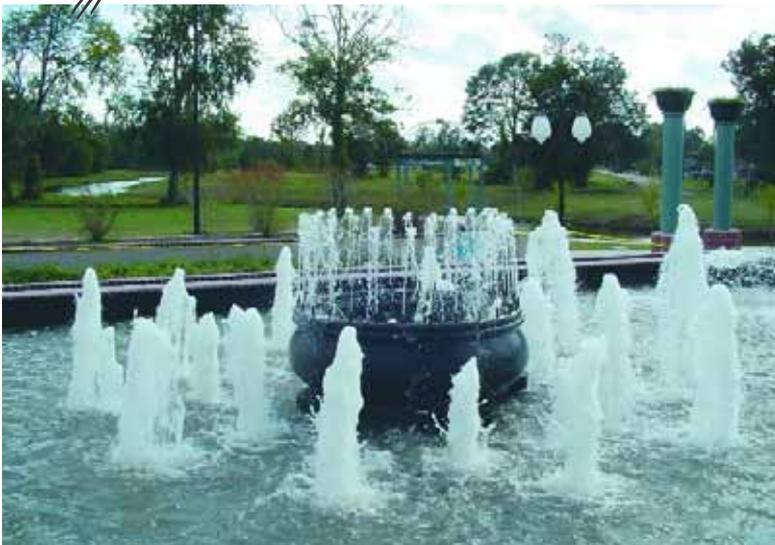
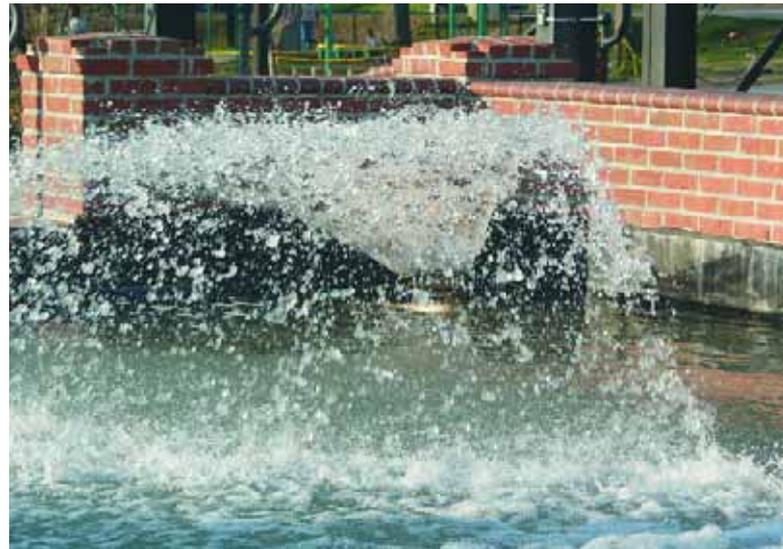
The restored fountain, with the cauldron at the center and dramatic fan jets in the corners, is now doing what it always should have done in adding drama and spectacle to Jambalaya Park both day and night.
