Once the site of an abandoned sewage plant, Jambalaya Park in Gonzalez, La., stands as testimony to just how ambitious a renovation project can be – and of how tangled the path to success sometimes becomes. As watershaper and watergarden specialist Les Ewen reports, the first attempt at installing the park’s fountain and Koi pond ended in a shambles, at which point he and his staff stepped in to put the city’s plans for the park back on track.

BY LES EWEN

JAMBALAYA

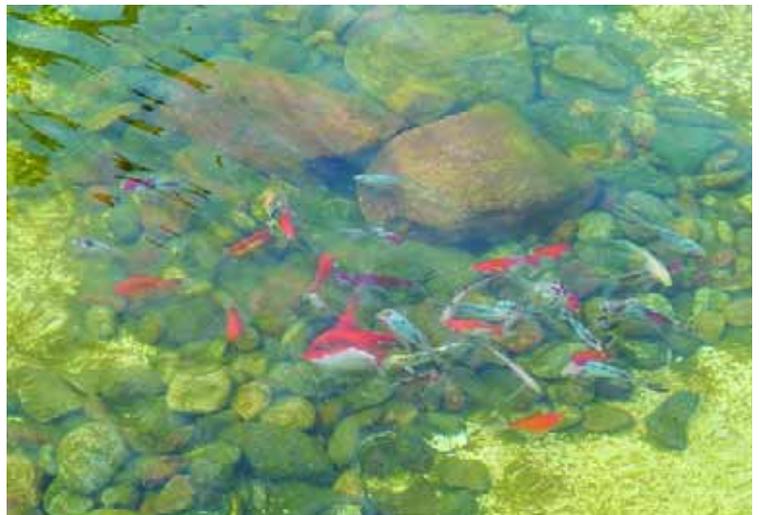
Among a variety of plumbing problems was a critical mistake with a check valve on the suction plumbing that had been installed to prevent backwash effluent from flowing back into the pond when the biological filter was being cleaned.

The valve, it turns out, had been installed horizontally rather than in the proper vertical configuration and never worked: Whenever the filter was pulled off-line for a cleaning, all of the muck was dumped right back into the water, choking it with nutrients, promoting algae growth and forcing a toxic environment on the fish.

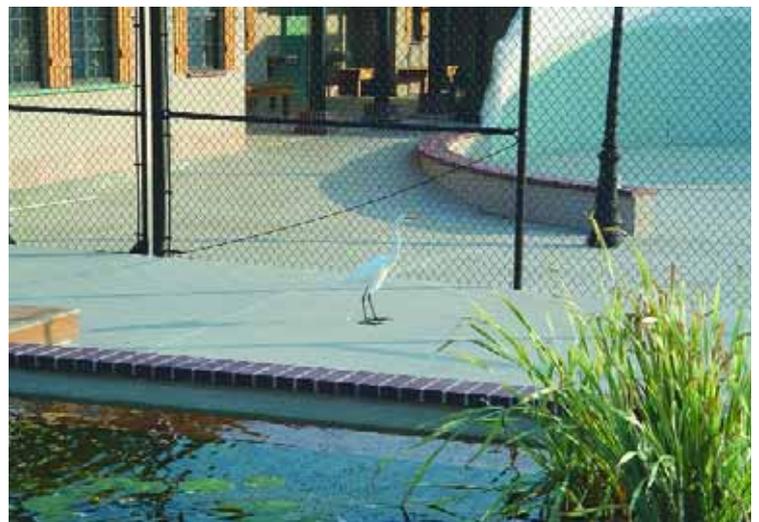
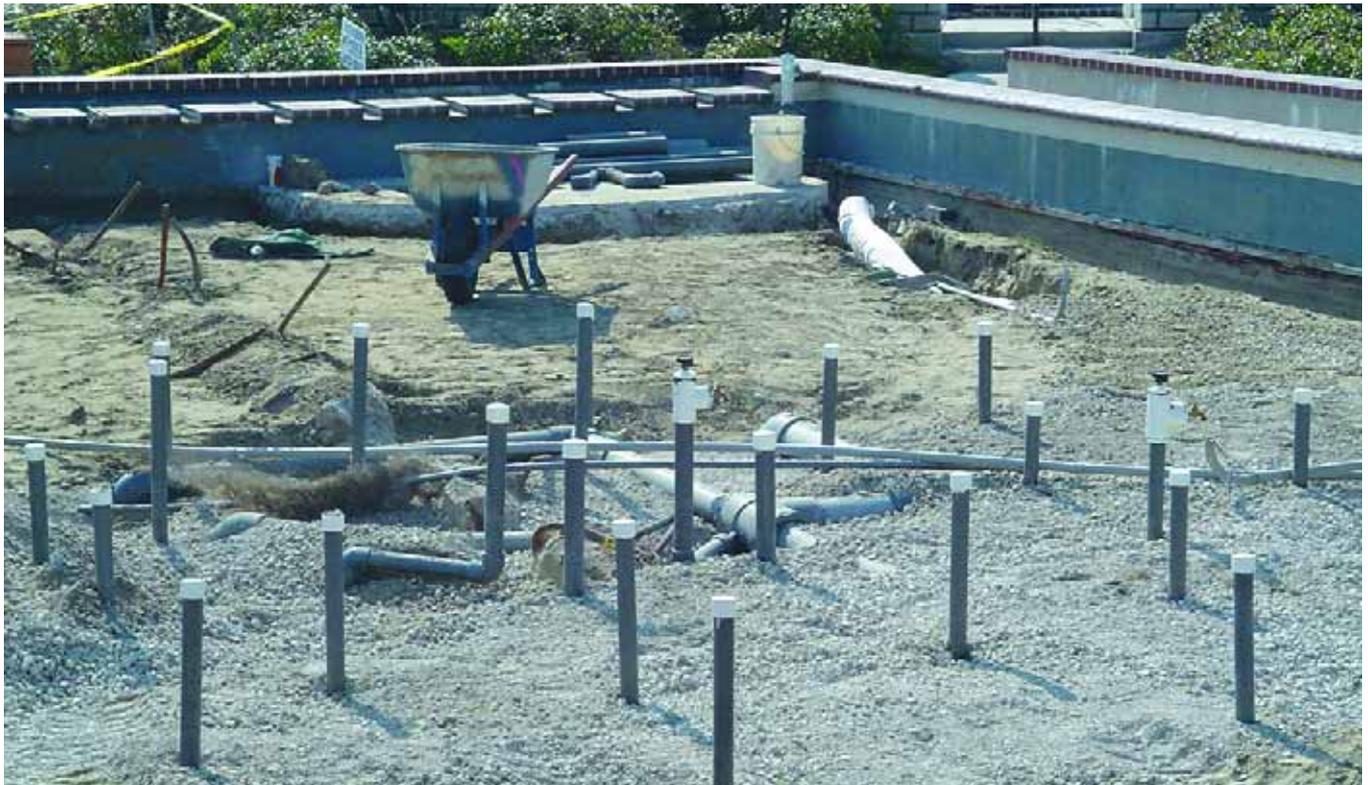
As we dug in, we found another problem with basic hydraulics. The biological filter should have been all that was needed to clean the water, but in addition to the improperly installed check valve, the pipes were too small and didn't allow proper flow through a 25-foot "bead" filter designed with a capacity of about 250 gallons per

minute. In our testing, we found that the actual flow rate of the initial installation was less than 50 gpm!

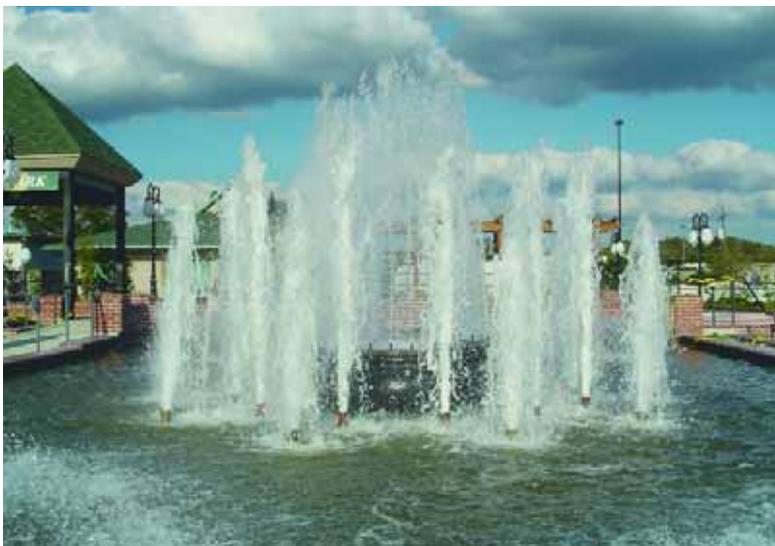
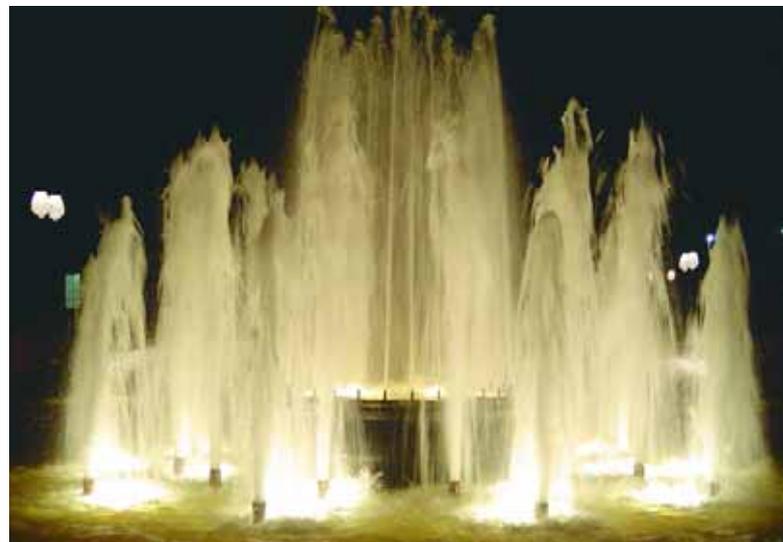
inch nozzles that shoot water up in a ring that converges about 20 feet in the air. The pot also has fixtures that illuminate the effect from inside the ring for spectacular nighttime displays.

Just outside the pot is another ring of three-inch nozzles that entrain air and send frothy jets 10 feet into the air, creating a second layer surrounding the cauldron. Beyond that ring are 16 cascade jets that send thick plumes of shaggy-looking water a couple of feet into the air. The four corners of the watershape have jets that send beautiful, wide fans of water back toward the center. Finally, there are 22 submersible halogen lights on the floor. All in all, it's a great display, day or night.
