Even for a firm that specializes in massive natural-stone watershapes, this Pennsylvania project was one for the record books. Working for an enthusiastic client who demanded beauty and visual drama on a truly enormous scale, the staff at Glacier Inc. stepped well beyond the usual in renovating a 78-acre private lake while creating a long, cascading stone stream and waterfall – with a grotto thrown in for good measure.

Up on

Rocky

By E.J. Biernesser,
Pete Biernesser
& Mike Raible

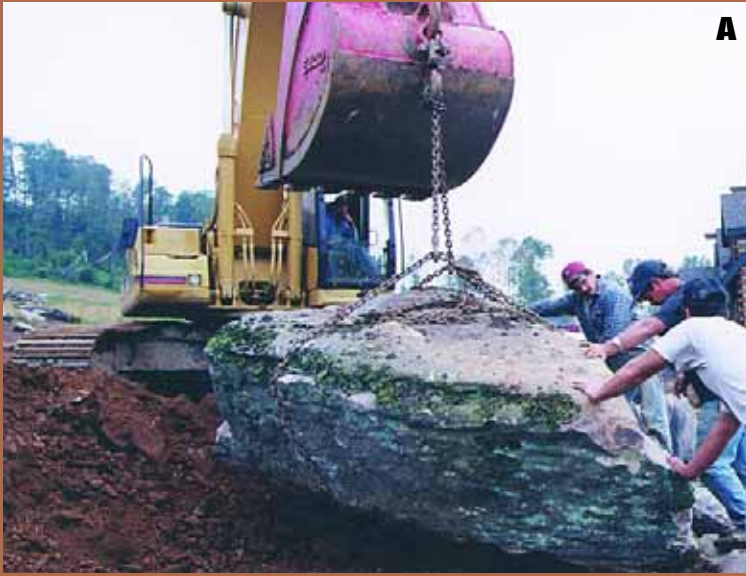
**A**

HEAVY DUTY: Our company operates quarries near our headquarters and in Maryland and Northern Pennsylvania, so we knew what we were getting into in setting up a quarry on our client's large estate. The distinction here was that we had to cut and build our own road from the outcroppings back to the construction site. Having the right equipment was essential – specifically, a 40-ton excavator for grappling with the stones (A) and a 30-ton off-road truck for transferring materials to the job site (B).

So our first steps involved cutting and building a roadway to reach the outcroppings we'd selected for quarrying. Then came setting up large staging areas for processing the stone and transferring it to trucks. Finally, we were ready to start

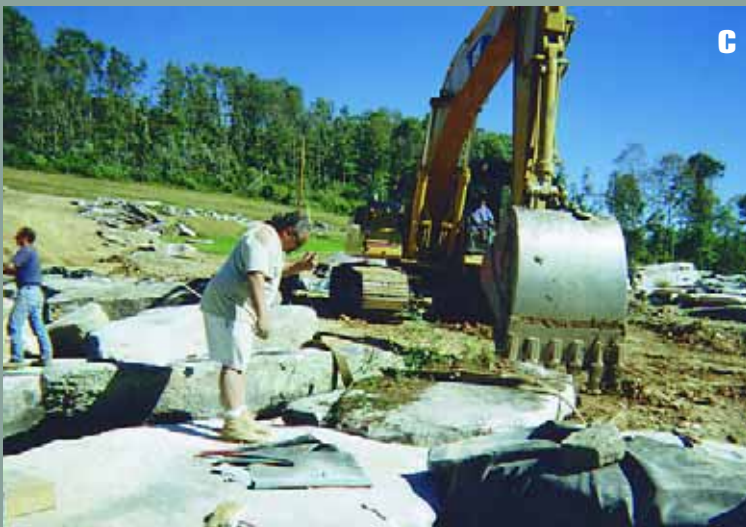
**C**

WALKING ON WATER: Of all the details in the project, this was the toughest to execute. Working lakeside with a 40-ton excavator shifting around 10-ton stones on a base of muck was no picnic (C), but we took a careful, considered, gradual approach and slowly worked our way out from the shore (D) to set up a half-submerged walkway (E) that, now complete, is enough to make any angler smile (F).

We recognized quickly that we'd have to claim this underwater turf foot by foot and began by reaching out into the water the full length of the excavator's boom, removing the muck and backfilling with a base of crushed limestone. Then we placed large boulders (with less desirable appearances) on the limestone and carefully advanced the excavator across the newly placed material – repeating the process again and again while moving farther and farther into the lake.

This process of transferring rocks the size of Volkswagens was treacherous, because the machine tracks were always completely submerged in water muddied

by the removal of all the muck. The operator literally had to “feel” his way across the rocks using the boom and bucket.

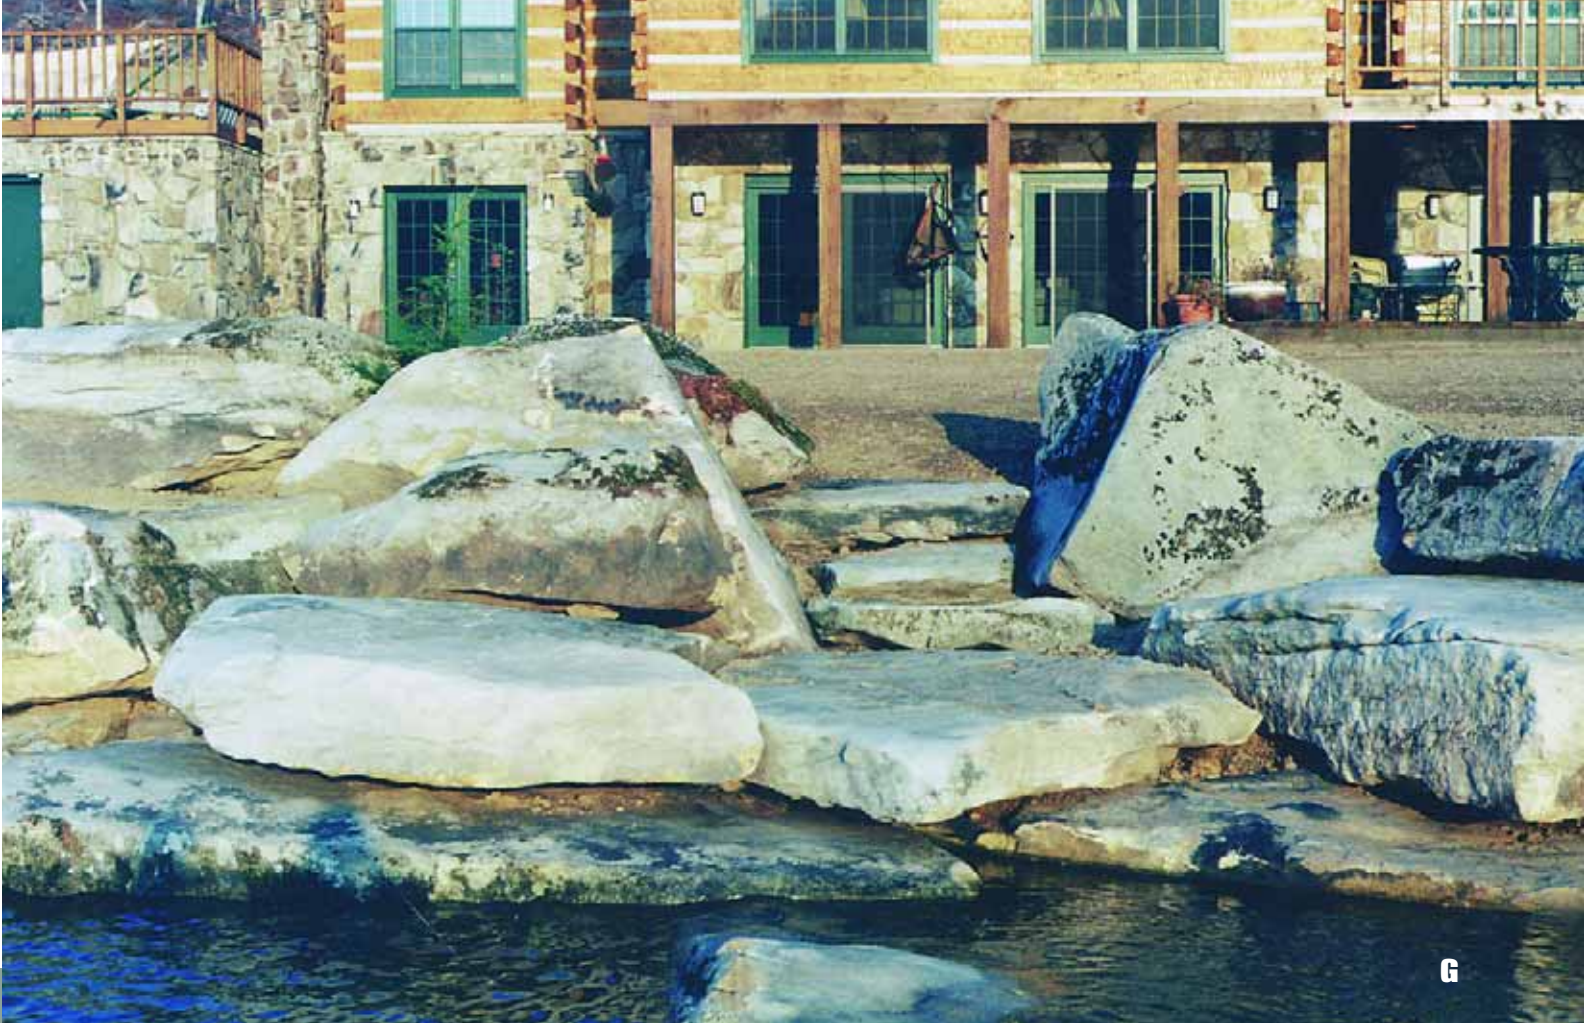
G

LAKEFRONT VIEWS: Our client was intent on having a rock-lined, glacial lakefront in front of the main house (G). We met the need by setting up a foundation of massive base stones atop which we set choice “finish stones” set up on multiple levels with interesting cantilevers – the whole serving as a waterfront walkway for our client and his guests (H).

terminated that by setting the stone material to rise five to seven feet out of the water, we would be able to achieve the desired visual effect while providing practical protection from erosion.

After excavation, we began by setting up a series of massive base stones, again using those that were not so visually desirable – but large and flat enough to provide a good foundation for the tonnage that they would be asked to support. Once the base stones were placed, we chose each subsequent stone by shape and contour to create interesting cantilevers for climbing and casting.

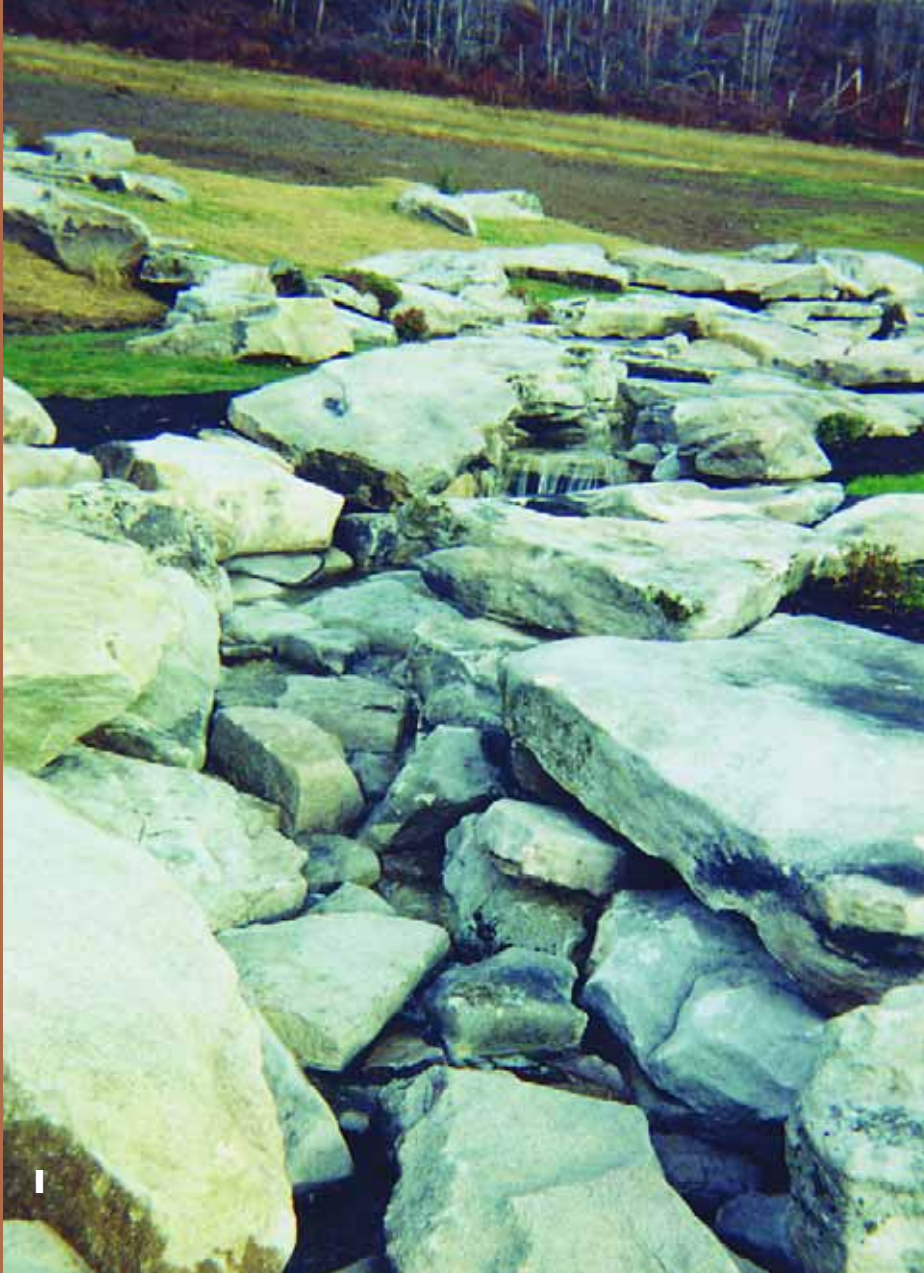
I

ON STREAM: The result looks like a glacial byproduct (I), and you can rest assured that the effort involved in making it look that way was just as titanic. Set up on a foundation of 200 yards of concrete, the spring-like source of the water is placed in the middle of the hillside, about halfway between the main house and the barn. It feeds the stream at a rate of 500 gallons per minute down to a waterfall that cascades into the lake (J). The process of “tuning” the stones to make the right sounds was a major part of the project (K), as was setting up a grotto that is now hidden behind the waterfall and overlooks a rock-bottom pool (L).

Construction of the stream, waterfall and grotto took six full months and ultimately consumed 125 cubic yards of concrete, 750 feet of 4-inch piping and 3,000 tons of sandstone – not to mention a tremendous amount of patience, stamina and creativity on the part of our crew.

In order to achieve a natural appearance and generate the desired sound, we adjusted the water depth in a series of pools, channels and cascades. This en-

abled us to vary the appearance, control the speed of the water flow and effectively “tune” the stream’s sound by adjusting the size and position of the stones.

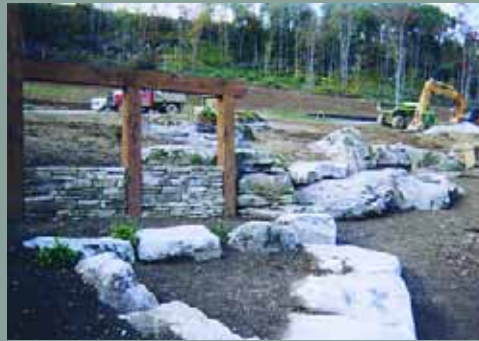
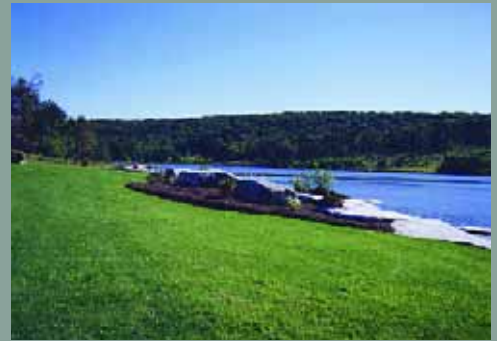
He wanted particularly to rehabilitate the grounds immediately surrounding the main house. We were happy to oblige with a low, stacked-stone wall built into an existing wooden arcade set off by a series of planting beds (left) and other planting areas marked by sandstone centerpieces (right).
